Manhole Inspection Summary

Manhole # S21U__006MH

Insp Date: **4/16/09 1:43 PM**

Location Address: **GWYNNS FALLS TRAIL**

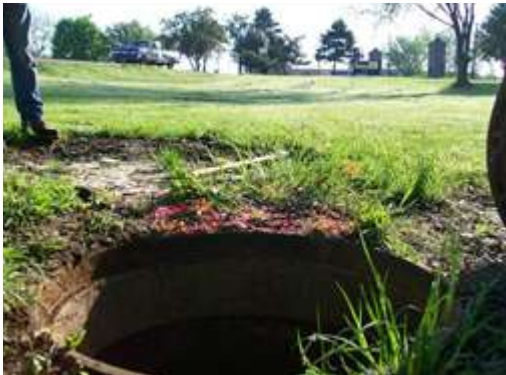
Location View

CARROLL PARK GOLF COURSE

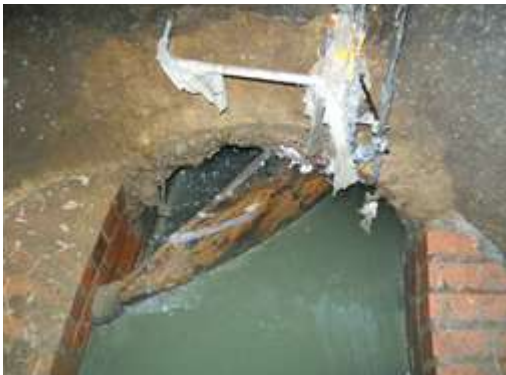
Defect 1

Condition: ☐ Sound ☐ Cracked ☐ Root Intrusion ☐ Deteriorated ☐ Leaks ☒ **Debris**

Surcharge ☒ **Evidence Of Surcharge** Depth: **5** (ft.) ☐ Active Surcharge Present

EVIDENCE OF SURCHARGE;
CHANNEL DEBRIS

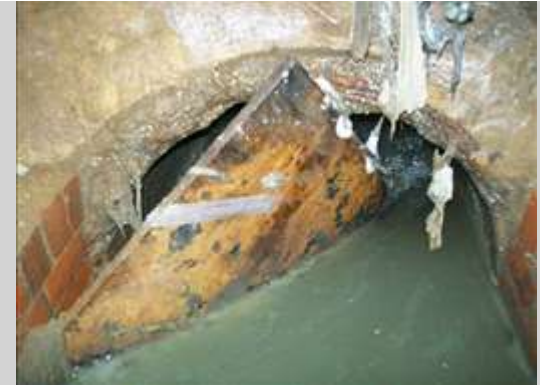
12 O'Clock Outflow

27 in. Circular Gravity Sewer
Pipe Out @ 12 O'Clock

Pipe Height: **27.6** (in.) Rod and Bar (Angled)
Pipe Material: **Concrete** ☐ Pipe Lined
Invert Depth: **22.80** (ft.) Flow Characteristics: **Fast**
Deposits: ☐ None ☐ Mud ☐ Sludge ☒ **Debris** ☐ Grease
Silt Depth: **18** (in.) Deposits Extent: **Heavy**
Infiltration: **None** Pipe Seal Cond: **Sound**

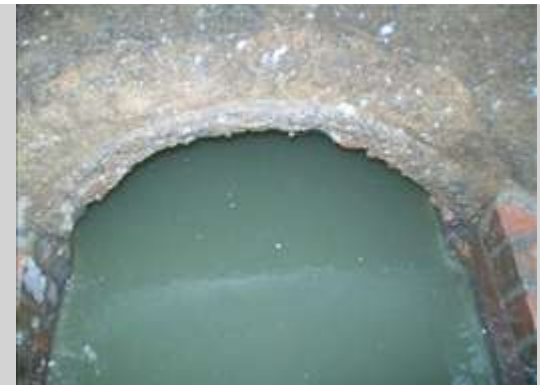
5 O'Clock Inflow

27 in. Circular Gravity Sewer
Pipe In @ 5 O'Clock

Pipe Height: **27.6** (in.) Rod and Bar (Angled)
Pipe Material: **Concrete** ☐ Pipe Lined
Invert Depth: **22.70** (ft.) Flow Characteristics: **Fast**
Deposits: ☒ **None** ☐ Mud ☐ Sludge ☐ Debris ☐ Grease
Silt Depth: **0** (in.) Deposits Extent:
Infiltration: **None** Pipe Seal Cond: **Sound**
